Manhole Inspection Summary

Manhole # S43Y__009MH

Location Address: **Behind school at 1400 block E. Fort Avenue**

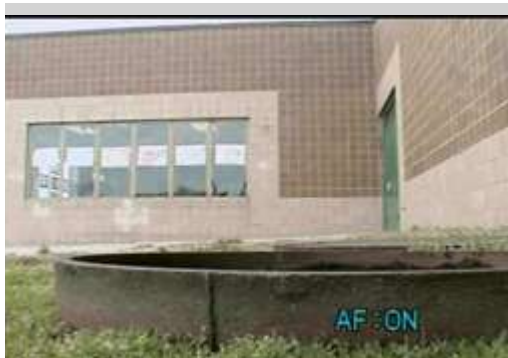
Location View

above grade

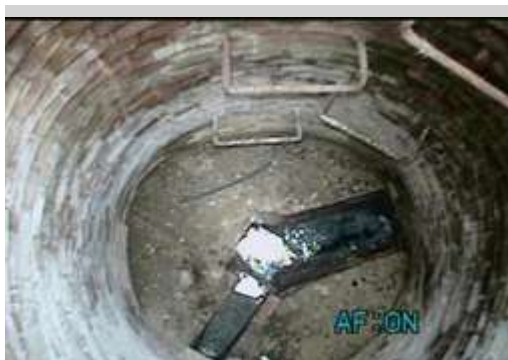
Misc

bench debris

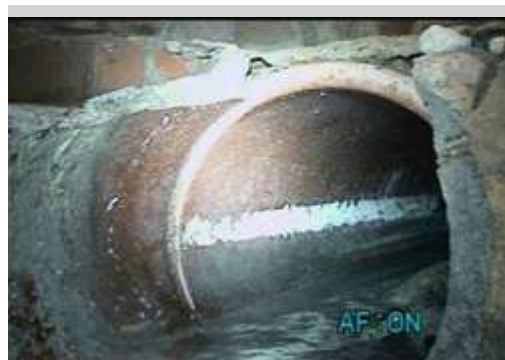
Misc

Pipe In @ 8 OClock

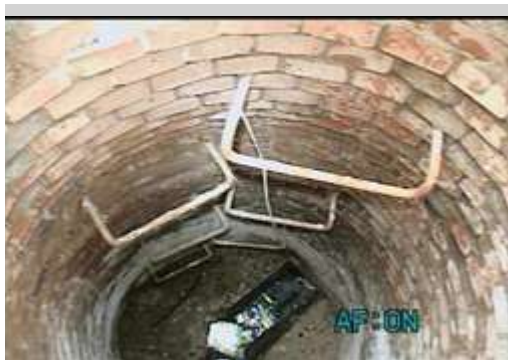
Defect 1

Count: **6** Missing: **0** ☒ **Corroded**

corroded steps

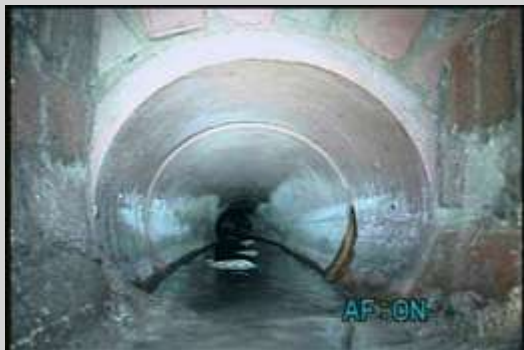
12 O'Clock Outflow

12 in. Circular Gravity Sewer
Pipe Out @ 12 O'Clock

Pipe Material: Clay ☐ Pipe Lined

Invert Depth: 12.05 (ft.) Flow Characteristics: Slow

Infiltration: None Pipe Seal Cond: Unknown

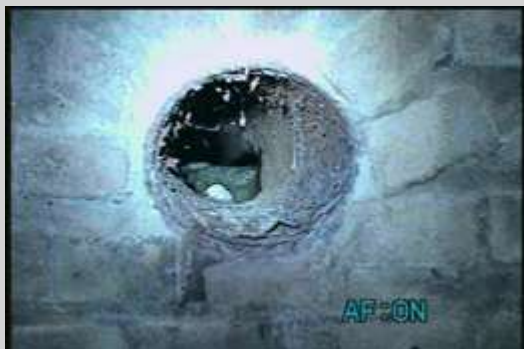
5 O'Clock Inflow

6 in. Circular Gravity Sewer
Pipe In @ 5 O'Clock

Pipe Material: Clay ☐ Pipe Lined

Invert Depth: 9.05 (ft.) Flow Characteristics: Slow

Infiltration: None Pipe Seal Cond: Unknown

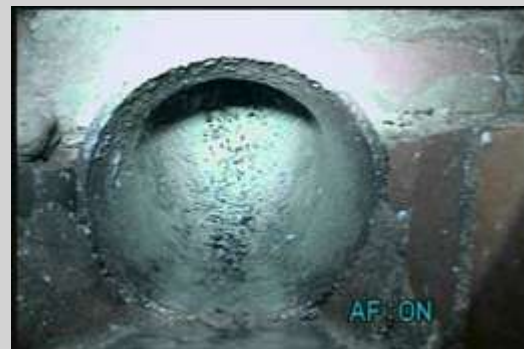
Drop In @ 5 O'Clock

Drop: Outside Direct

Inv Depth: 11.41 (ft.)

Drop Condition: Open

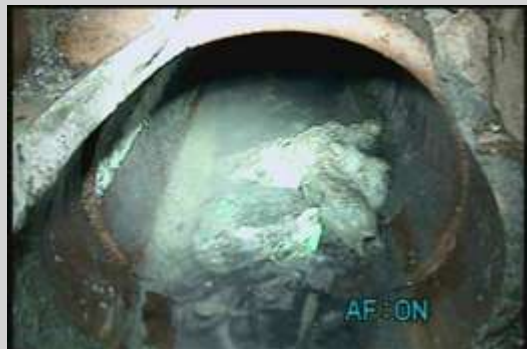
8 O'Clock Inflow

12 in. Circular Gravity Sewer
Pipe In @ 8 OClock

Pipe Material: **Clay** ☐ Pipe Lined

Invert Depth: **12.16** (ft.) Flow Characteristics: **Fast**

Infiltration: **None** Pipe Seal Cond: **Unknown**
